【事例 - 3 1】 冷凍事業所のヒヤリハット(1)

【事例 - 3 2】 冷凍事業所のヒヤリハット（2）

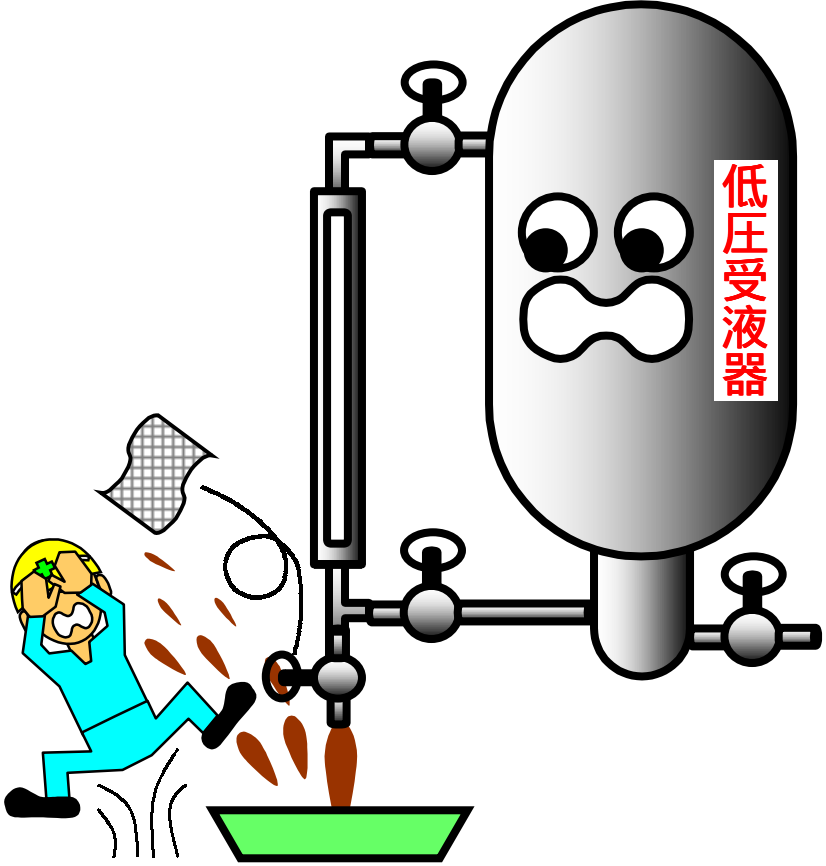
<p>内 容</p>	<p>開け過ぎた油抜弁を温湿布してガスが漏えい</p>
<p>状 況</p>	<p>・ R 2 2 冷凍設備の低圧受液器に設けた液面計のフロートヘッダーから油抜きをするため油抜弁を開けたが、なかなか抜けないので弁を温湿布していたところ、突然、冷媒液が噴出漏えいした。油抜弁を開け過ぎていた。</p>
<p>想 定 される 事 故</p>	<p>・ 噴出冷媒による凍傷、酸欠事故</p>
<p>概略図</p>

<p>対 策</p>	<ul style="list-style-type: none"> <li>・ 冷媒設備の弁は、少しずつ開放</li> <li>・ 油抜き作業は、冷媒の漏えいを考慮し、換気装置の運転状態に注意</li> <li>・ 油が滞留しないよう定期的に油抜き作業を実施</li> </ul>
